# Reliability of Scanning Laser Acoustic Microscopy for Detecting Internal Voids in Structural Ceramics

Don J. Roth and George Y. Baaklini  
*Lewis Research Center*  
*Cleveland, Ohio*

Prepared for the  
Tenth Annual Conference on Composites and  
Advanced Ceramic Materials  
sponsored by the American Ceramic Society  
Cocoa Beach, Florida, January 19-22, 1986

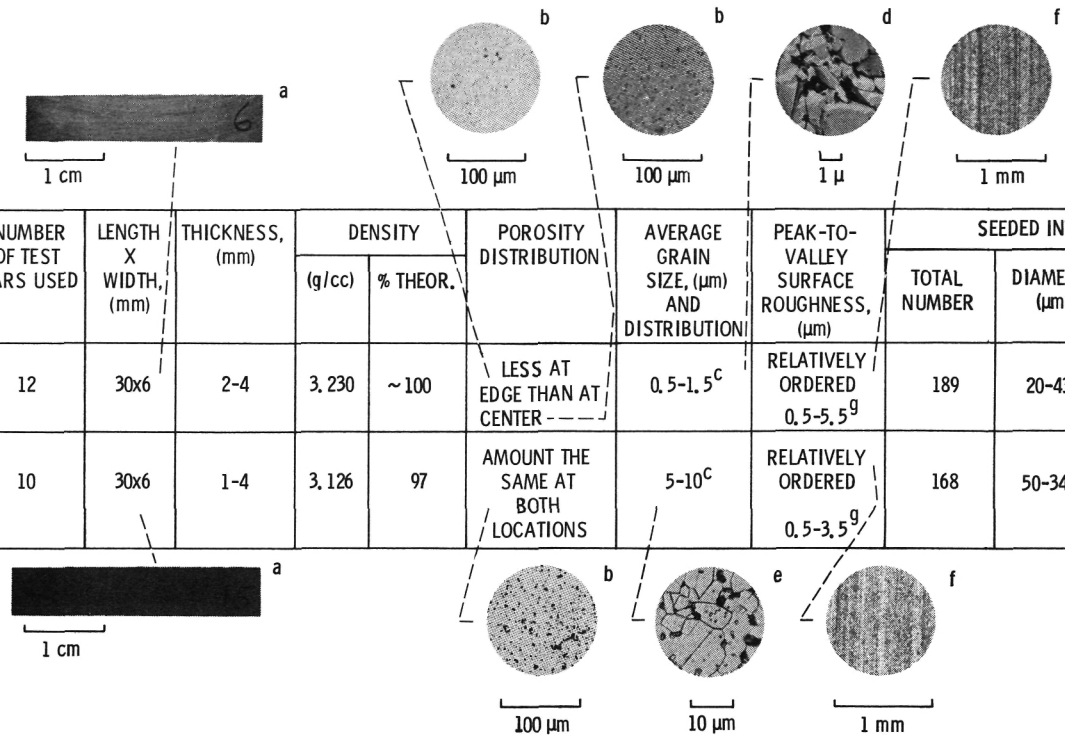
TABLE 1. CHARACTERIZATION OF SPECIMENS

TEST BAR MATERIAL	NUMBER OF TEST BARS USED	LENGTH X WIDTH, (mm)	THICKNESS, (mm)	DENSITY		POROSITY DISTRIBUTION	AVERAGE GRAIN SIZE, (μm) AND DISTRIBUTION	PEAK-TO-VALLEY SURFACE ROUGHNESS, (μm)	SEEDED INTERNAL VOIDS		
				(g/cc)	% THEOR.				TOTAL NUMBER	DIAMETER (μm)	DEPTH BELOW SPECIMEN SURFACE (mm)
SINTERED $\text{Si}_3\text{N}_4$ (SSN)	12	30x6	2-4	3,230	~100	LESS AT EDGE THAN AT CENTER	0.5-1.5 <sup>c</sup>	RELATIVELY ORDERED 0.5-5.5 <sup>g</sup>	189	20-430	0-2
SINTERED SiC (SSC)	10	30x6	1-4	3,126	97	AMOUNT THE SAME AT BOTH LOCATIONS	5-10 <sup>c</sup>	RELATIVELY ORDERED 0.5-3.5 <sup>g</sup>	168	50-340	0-2

<sup>a</sup>OPTICAL PHOTOGRAPH OF DIAMOND-GROUND SPECIMEN

<sup>b</sup>OPTICAL MICROGRAPH OF POLISHED SPECIMEN (BLACK SPOTS INDICATE POROSITY)

<sup>c</sup>AVERAGE GRAIN SIZES OBTAINED USING THE HEYN INTERCEPT (MEAN FREE PATH) METHOD GIVEN IN ASTM E112-81

<sup>d</sup>TRANSMISSION ELECTRON MICROGRAPH OF REPLICA OF POLISHED AND ETCHED SPECIMEN

<sup>e</sup>OPTICAL MICROGRAPH OF POLISHED AND ETCHED SPECIMEN

<sup>f</sup>OPTICAL MICROGRAPH OF DIAMOND-GROUND SPECIMEN

<sup>g</sup>SURFACE PROFILE (USING A 12.5 μm DIAMETER DIAMOND STYLUS) OF DIAMOND-GROUND SPECIMEN PERPENDICULAR TO GRINDING MARKS

Table I describes the sintered specimens in detail. The specimens, similar in shape to modulus-of-rupture (MOR) test bars, were approximately 30 mm long and 6 mm wide and varied in thickness from 2 to 4 mm for SSN and 1 to 4 mm for SSC. Although the magnitude of the surface roughness varied, the roughness was relatively ordered (unidirectional) due to surface grinding. The SSN specimens contained less porosity than the SSC specimens and had an average grain size approximately an order of magnitude smaller than that for SSC specimens. The positions of seeded voids are illustrated in figure 2 which shows top (thru-thickness) and side view (thru-width) microfocus radiographs of a region in a typical SSN test bar.

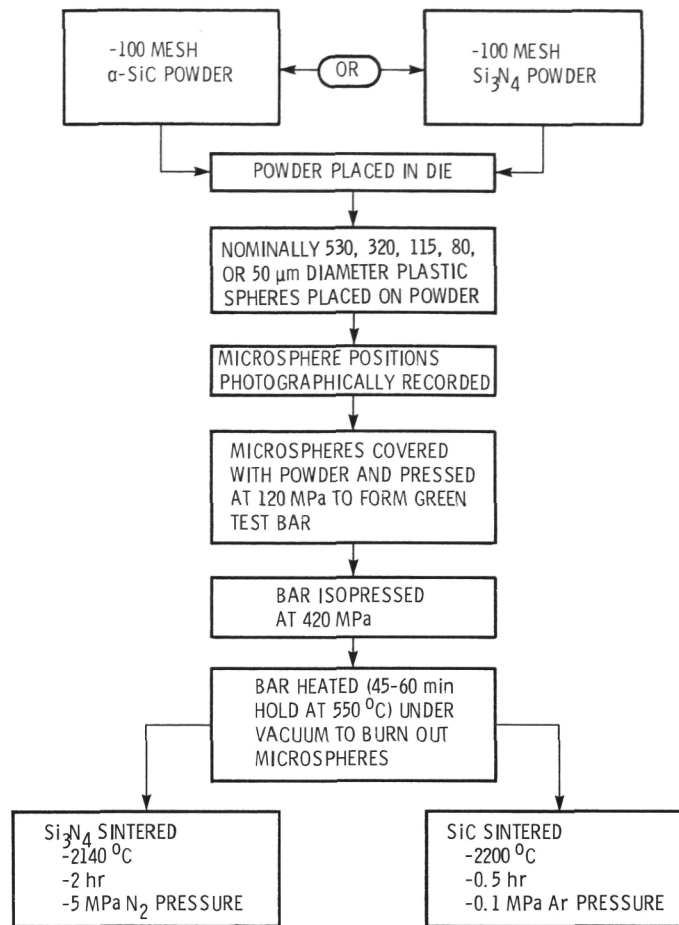
Figure 1. Fabrication of the sintered silicon nitride and sintered silicon carbide test specimens with seeded internal voids.

Twelve sintered  $\text{Si}_3\text{N}_4$  (SSN) specimens containing a total of 189 seeded internal voids and 10 sintered  $\text{SiC}$  (SSC) specimens containing a total of 168 seeded internal voids were inspected with SLAM. The processing steps used to fabricate the test specimens are shown in figure 1 and described in detail in reference 16. Briefly, plastic microspheres of various sizes were embedded in green specimens and later burned out to create voids within sintered specimens. During formation of a specimen, a powder layer with the microspheres exposed to the surface was photographed so that approximate positions of the resulting voids would be known for SLAM inspections.

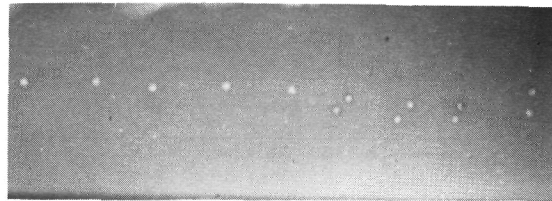
(a) Top view (thru-thickness).

(b) Side view (thru-width).

Figure 2. - Microfocus radiographs of a region of a typical sintered silicon nitride test bar showing the location of the seeded internal voids. The white spots indicate the voids. (Initial sphere size =  $320\mu\text{m}$ )

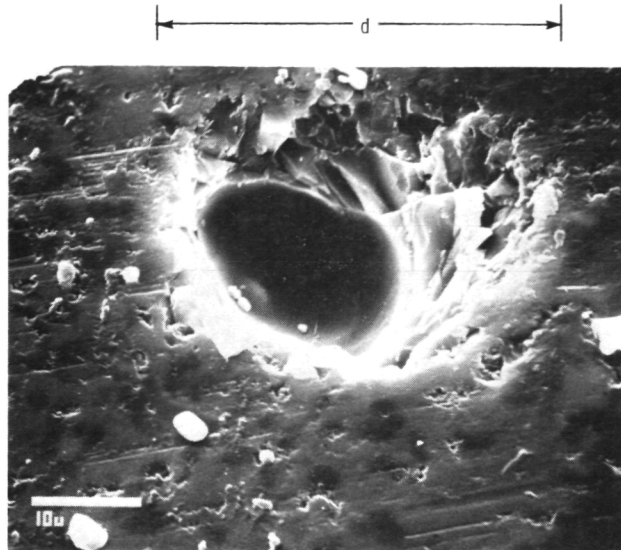
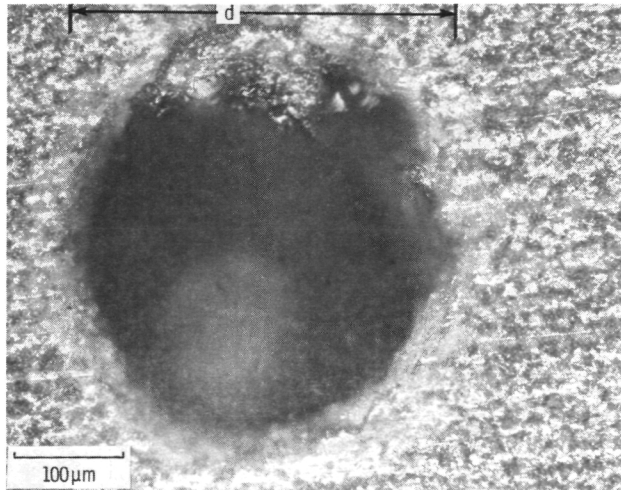
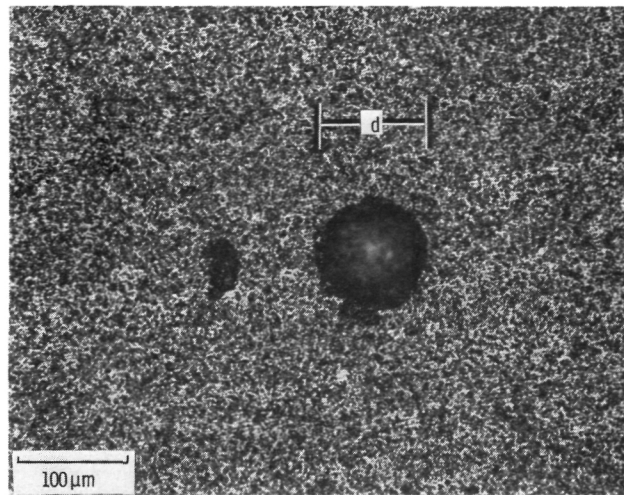
(a) Scanning electron micrograph of void approximately  $30\mu\text{m}$  in diameter in a sintered silicon nitride specimen.

(b) Optical micrograph of void approximately  $400\mu\text{m}$  in diameter in a sintered silicon nitride specimen.

Figure 3. - Micrographs of representative seeded internal voids exposed to the specimen surface. ( $d$  = diameter)

(c) Optical micrograph of void approximately 100  $\mu\text{m}$  in diameter in a sintered silicon carbide specimen.

Representative seeded internal voids in SSN and SSC specimens are shown exposed to the surface in the micrographs of figure 3. The seeded voids were similar in morphology to naturally-occurring voids in fractured MOR bars of the same material (ref. 16). The voids ranged from 20 to 430  $\mu\text{m}$  in diameter in SSN and from 50 to 340  $\mu\text{m}$  in diameter in SSC and were positioned at depths ranging up to 2 mm below the specimen surface in both materials.

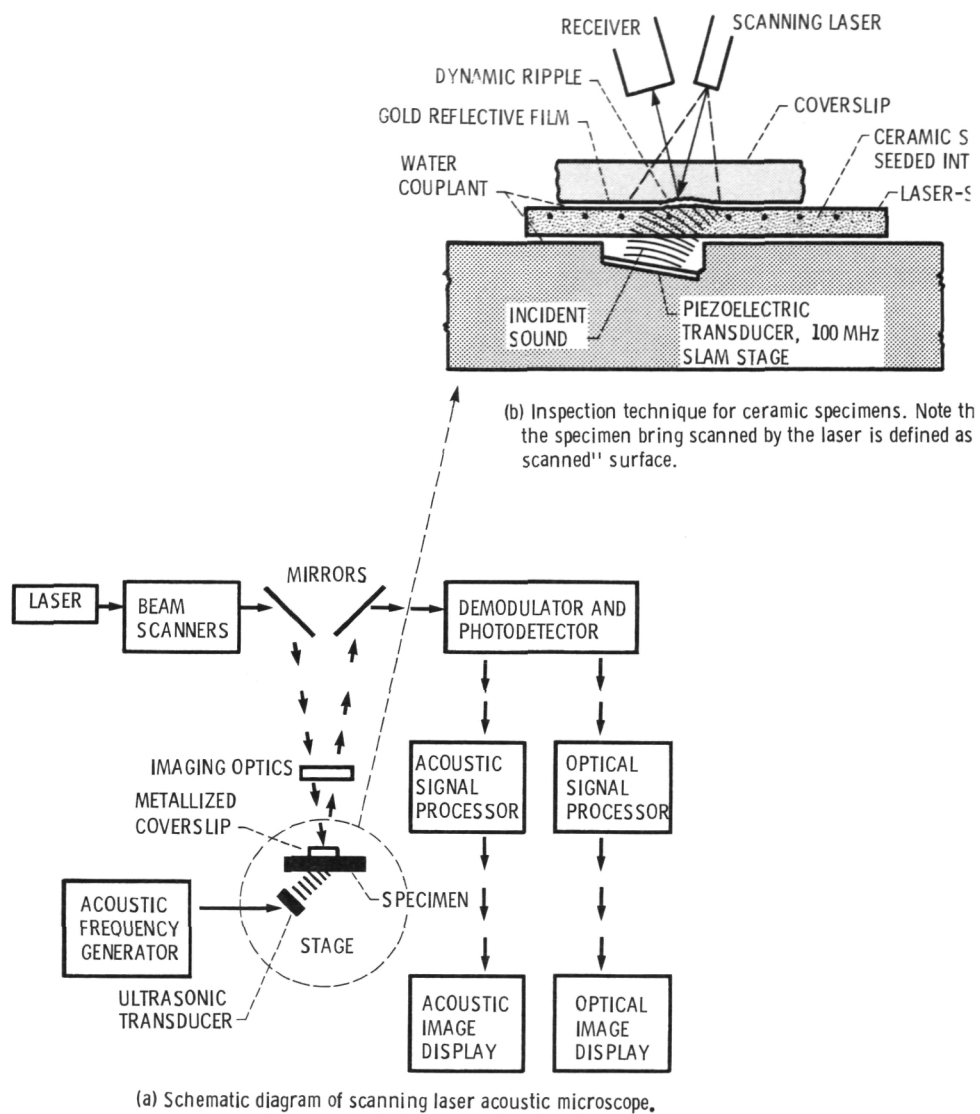
Figure 4 - Scanning laser acoustic microscopy.

The specimens were alternately ground to remove material from the surface and inspected with SLAM so that detectability data for the same seeded void population could be gathered for various depths. The SLAM apparatus used for inspection of the ceramic test bars is shown in figure 4 and described in detail in references 17, 19, and 20. Briefly, continuous 100 MHz ultrasonic waves traveling thru the specimen produce microdistortions on the specimen surface opposite the incident sound source. The distortion pattern, determined by the microstructural, bulk, and surface features of the material, is transmitted via water coupling to the reflective coating of a plastic coverslip placed on the specimen. A rastering laser beam, modulated by the distortion

pattern, is reflected to a photodetector and converted to an electronic signal. In this matter, an "acoustic" image of the specimen, including surface and internal flaws such as voids, inclusions, and cracks, is obtained and displayed on a video monitor in real-time. Only specimens having nearly flat and parallel surfaces can be inspected using the SLAM configuration shown in figure 4(b). The surface of the specimen nearest the laser is herein defined as the "laser-scanned" surface for discussion purposes.

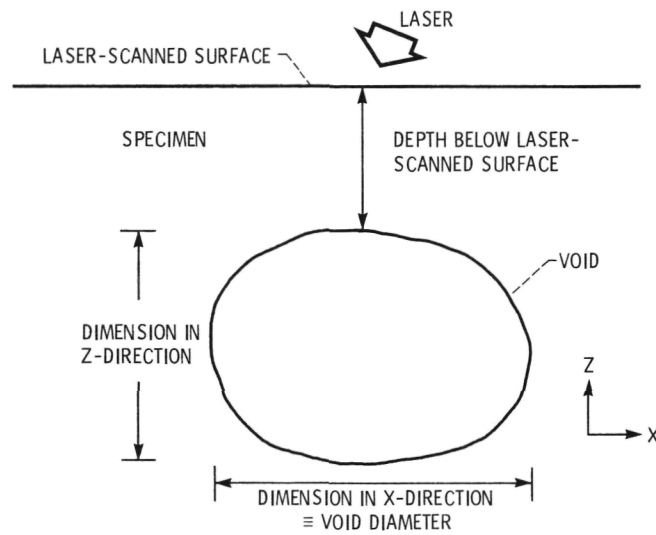
Figure 5. - Illustration showing definitions of void diameter and depth of void below the laser-scanned surface. Voids had an ellipsoidal geometry with the dimension in the Z-direction always shorter than the dimension in the X-direction.

After being exposed to the surface, the dimensions of each void were measured and the depth at which the void was initially detected with SLAM was determined (see fig. 5). The voids were ellipsoidal with the dimension of the void in the z-direction always shorter than the dimension in the x-direction (ref. 16). The depth at which a void was initially detected was calculated by subtracting the specimen thickness at which the void was just exposed to the surface from the thickness at the inspection during which the void was initially detected. The estimated error in the void dimension and depth measurements was approximately 10 percent.

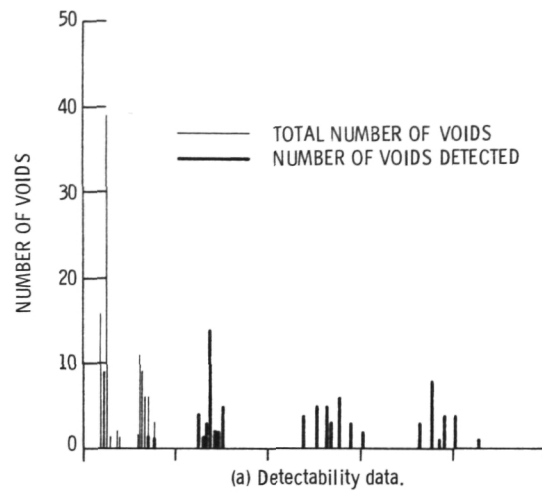
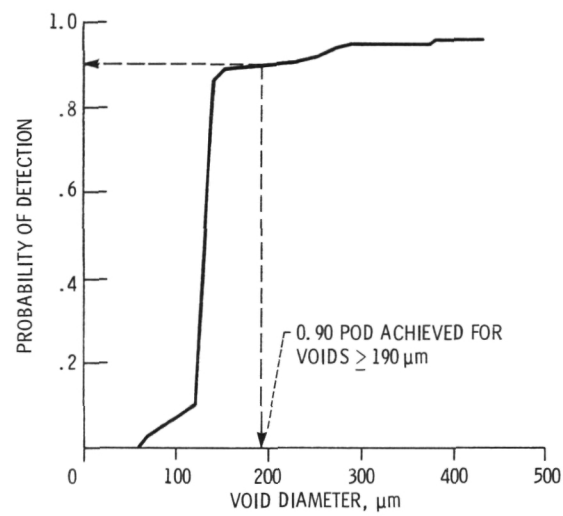
Figure 6. - Detectability data and corresponding probability of detection (POD) for seeded voids 300-400  $\mu\text{m}$  below the laser-scanned surface in sintered silicon nitride. Probability was calculated at a 0.95 confidence level.

Detectability data for the seeded voids and corresponding POD curves at each depth range for SSN and SSC specimens are given in appendices A and B, respectively. Curves are not presented for the 700 to 2000  $\mu\text{m}$  depth ranges for SSC because POD was zero at depths greater than 700  $\mu\text{m}$  in the SSC specimens. Figure 6 shows a sample set of detectability data and corresponding POD curve for seeded voids 300 to 400  $\mu\text{m}$  deep in SSN. Voids 190  $\mu\text{m}$  in diameter or larger were detected with at least 0.90 probability at this depth range in SSN.

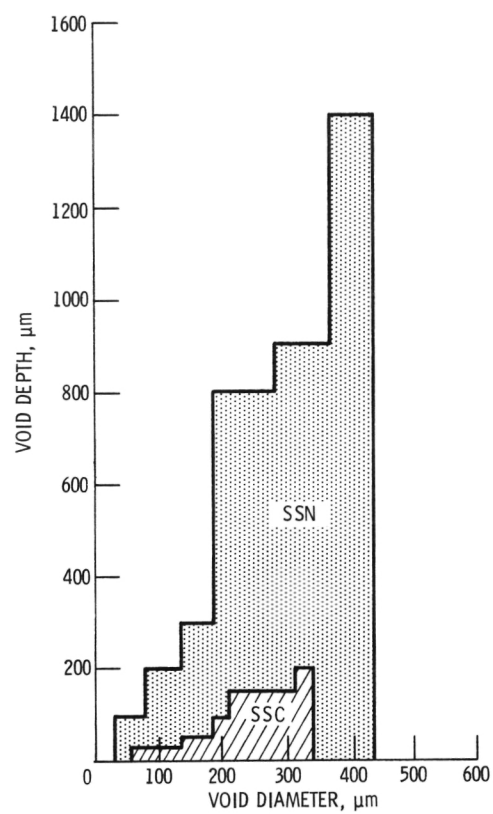
Figure 7. - 0.90 Probability of detection as a function of material, void diameter, and void depth below the laser-scanned surface. SSN  $\equiv$  sintered silicon nitride. SSC  $\equiv$  sintered silicon carbide.

Figure 7 shows a plot of 0.90 POD as a function of material, void diameter, and void depth. The range of depths and diameters for which 0.90 or higher POD was achieved is indicated by the outlined regions for SSN and SSC. As examples, voids approximately 50, 200, and 400  $\mu\text{m}$  in diameter in SSN were detected with at least 0.90 probability if within 100, 800, and 1400  $\mu\text{m}$  of the laser-scanned surface, respectively. Voids approximately 75, 200, and 300  $\mu\text{m}$  in diameter in SSC were detected with at least 0.90 probability if within 25, 100, and 150  $\mu\text{m}$  of the laser-scanned surface, respectively. The smallest voids for which 0.90 POD was achieved were 30  $\mu\text{m}$  in diameter in SSN and 60  $\mu\text{m}$  in diameter in SSC. It is worth noting that this result was limited by the smallest seeded voids upon which statistical data was gathered (20  $\mu\text{m}$  in diameter in SSN and 50  $\mu\text{m}$  in diameter in SSC) and the conservative plotting procedure used for the POD curves. It is felt that 0.90 POD would have been achieved for voids on the order of 10  $\mu\text{m}$  in diameter if within approximately 25  $\mu\text{m}$  of the

laser-scanned surface in both materials. Figure 7 shows that for either SSN or SSC, 0.90 POD was achieved over greater depths for larger voids than for smaller voids and that for equally-sized voids, 0.90 POD was achieved over considerably greater depths in SSN than in SSC.

Points outside an outlined region indicate diameters and depths of voids that may have been detected but with less than 0.90 probability. At depths of 1400 to 2000  $\mu\text{m}$  in SSN and 200 to 2000  $\mu\text{m}$  in SSC, no voids in the size range investigated were detected with 0.90 probability (see appendices A and B). This occurred either because void detectability was low, as was the case for SSC, or a sufficient statistical sample of voids was unavailable at the larger void diameters, as was the case for SSN.

why 0.90 POD was achieved over much greater depths in SSN than in SSC for similarly-sized voids (see fig. 7).

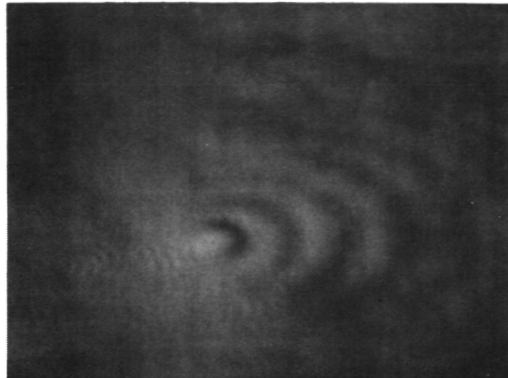
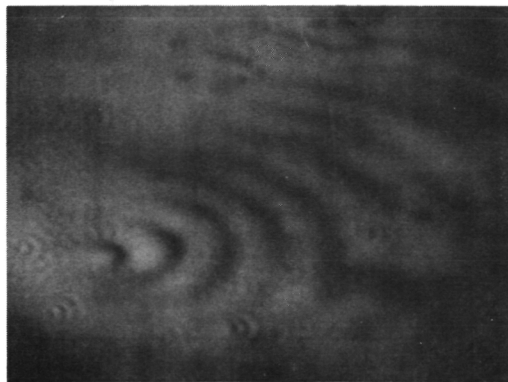
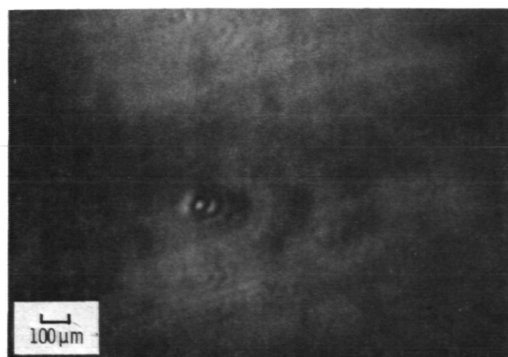
(a) Void depth  $\approx 100\mu\text{m}$ .

(b) Void depth  $\approx 50\mu\text{m}$ .

(c) Void depth  $\approx 25\mu\text{m}$ .

(d) Void just broken thru surface.

Figure 8. - Acoustic micrographs of a seeded internal void  $30\mu\text{m}$  in diameter (shown exposed to the surface in figure 3a) in a sintered silicon nitride specimen at various depths below the laser-scanned surface. Void was initially detected at a depth of approximately  $100\mu\text{m}$ .

The initial SLAM detection of each void was accomplished by noting the appearance of a diffuse, ring-like diffraction pattern (see figs. 8(a), 9(a), and 10(a)). As the relative depth of each void was reduced by grinding away material from the laser-scanned surface, the void's diffraction pattern became more pronounced making the void easier to detect. As shown in figures 8(b) to (d), 9(b) to (d), and 10(b) to (c), the first (innermost) diffraction ring became less diffuse and/or additional (concentric) diffraction rings began to appear as the relative depth was reduced. Hence, once detected at a given depth, a void would be detected at lesser depths.

As expected, a larger void was more easily detected than was a smaller void at a given depth in either SSN or SSC. This can be seen by comparing the acoustic images of a 30  $\mu\text{m}$  void (fig. 8(a)) and a 400  $\mu\text{m}$  void (fig. 9(d)) approximately 100  $\mu\text{m}$  below the laser-scanned surface in SSN. Similarly, larger voids were initially detected at greater depths than were smaller voids. As shown in figures 8 and 9, respectively, a 30  $\mu\text{m}$  void was first detected at a depth of approximately 100  $\mu\text{m}$  while a 400  $\mu\text{m}$  void was first detected at a depth of approximately 1700  $\mu\text{m}$  in SSN. This explains why 0.90 POD was achieved over greater depths for larger voids than for smaller voids in either SSN or SSC (see fig. 7).

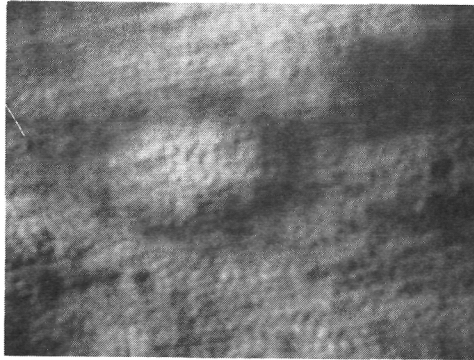
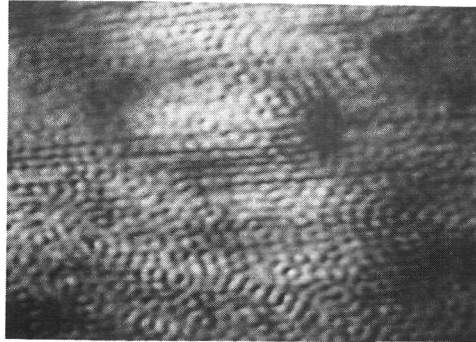
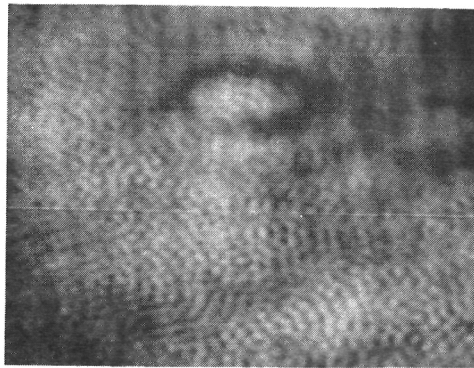
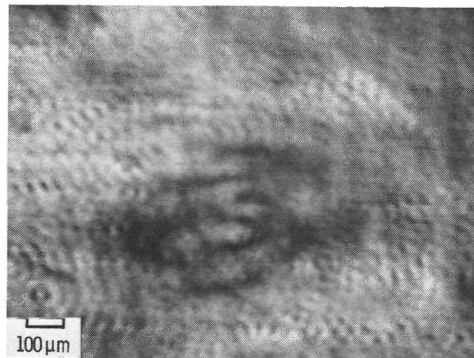
(a) Void depth  $\approx 1700\mu\text{m}$ .

(b) Void depth  $\approx 1300\mu\text{m}$ .

(c) Void depth  $\approx 700\mu\text{m}$ .

(d) Void depth =  $100\mu\text{m}$ .

Figure 9. - Acoustic micrographs of a seeded internal void  $400\mu\text{m}$  in diameter (shown exposed to the surface in figure 3b) in a sintered silicon nitride specimen at various depths below the laser-scanned surface. Void was initially detected at a depth of approximately  $1700\mu\text{m}$ .

In this study, background noise attributable to surface roughness effects was negligible because the laser-scanned surface was in the as-ground condition. (The opposite surface of the specimen was left in the as-fired condition.) Only weak striations produced by grinding marks were apparent in acoustic images (see fig. 9(a)), and the diffraction patterns of internal voids dominated.

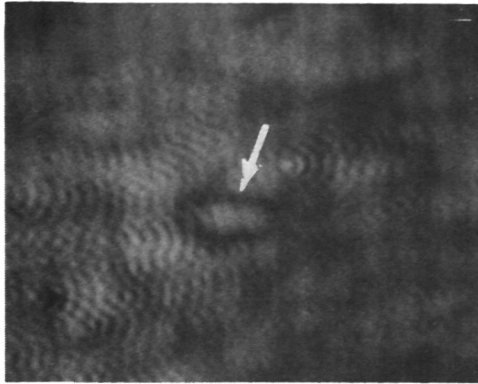
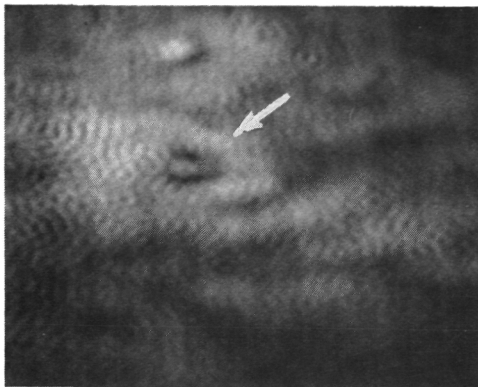
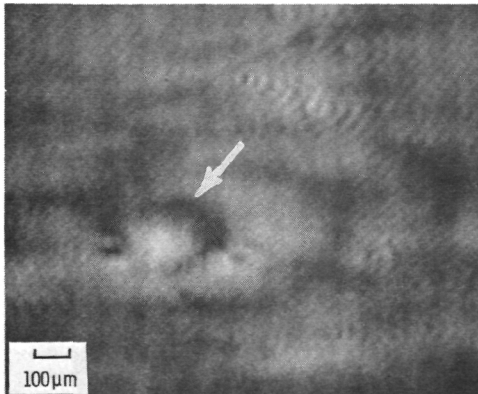
(a) Void depth  $\approx 100\mu\text{m}$ .

(b) Void depth  $\approx 50\mu\text{m}$ .

(c) Void depth  $\approx 25\mu\text{m}$ .

Figure 10. - Acoustic micrographs of a seeded internal void  $100\mu\text{m}$  in diameter (shown exposed to the surface in figure 3c) in a sintered silicon carbide specimen at various depths below the laser-scanned surface. Void was initially detected at a depth of approximately  $100\mu\text{m}$ . Seeded void diffraction pattern is noted by arrow to distinguish it from the images of naturally-occurring flaws.

At any given depth, voids were generally easier to detect in SSN than in SSC. Moreover, a much sharper decrease in void detectability with increasing depth was observed for SSC as compared with SSN. The acoustic images of SSC were typically noisier than those of SSN making the acoustic diffraction patterns of voids more difficult to distinguish in SSC than in SSN. These findings indicated that SSC contained more acoustic scattering sites that were undoubtedly due to the markedly coarser grain structure and greater porosity of SSC (ref. 26 and 27). The difference in void detectability between the two materials is illustrated by comparing figures 8 and 10. At similar depths, the diffraction pattern of a 30  $\mu\text{m}$  void in SSN (see fig. 8) was much easier to discern than that of a 100  $\mu\text{m}$  void in SSC (see fig. 10). These factors explain

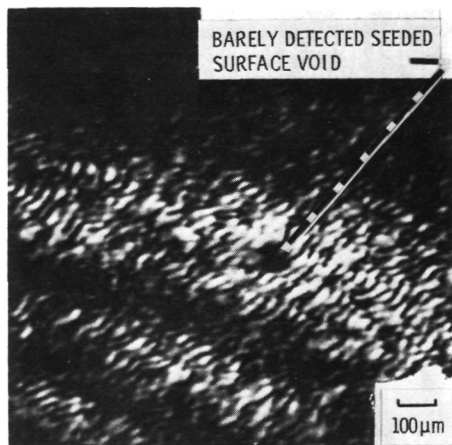
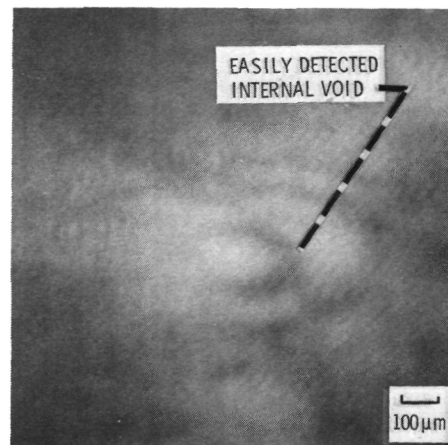
(a) Acoustic image of as-fired specimen. Noise attributed to surface roughness is substantial.

(b) Acoustic image of as-ground specimen. Noise attributed to surface roughness is negligible.

Figure 11. - Effect of surface condition on void detectability in structural ceramics with SLAM. Illustration of void detectability in as-fired specimens taken from reference 19.

Figure 11 illustrates the effect of surface condition on void detectability in structural ceramics with SLAM. Void detectability was shown in reference 19 to critically depend on the condition of the laser-scanned surface. In that study, significant background noise was present in the acoustic images of as-fired specimens. Seeded surface voids were masked by the noise making them difficult if not impossible to detect. Background noise was substantially reduced after polishing only the laser-scanned surface. Consequently, the seeded surface voids were readily detected.

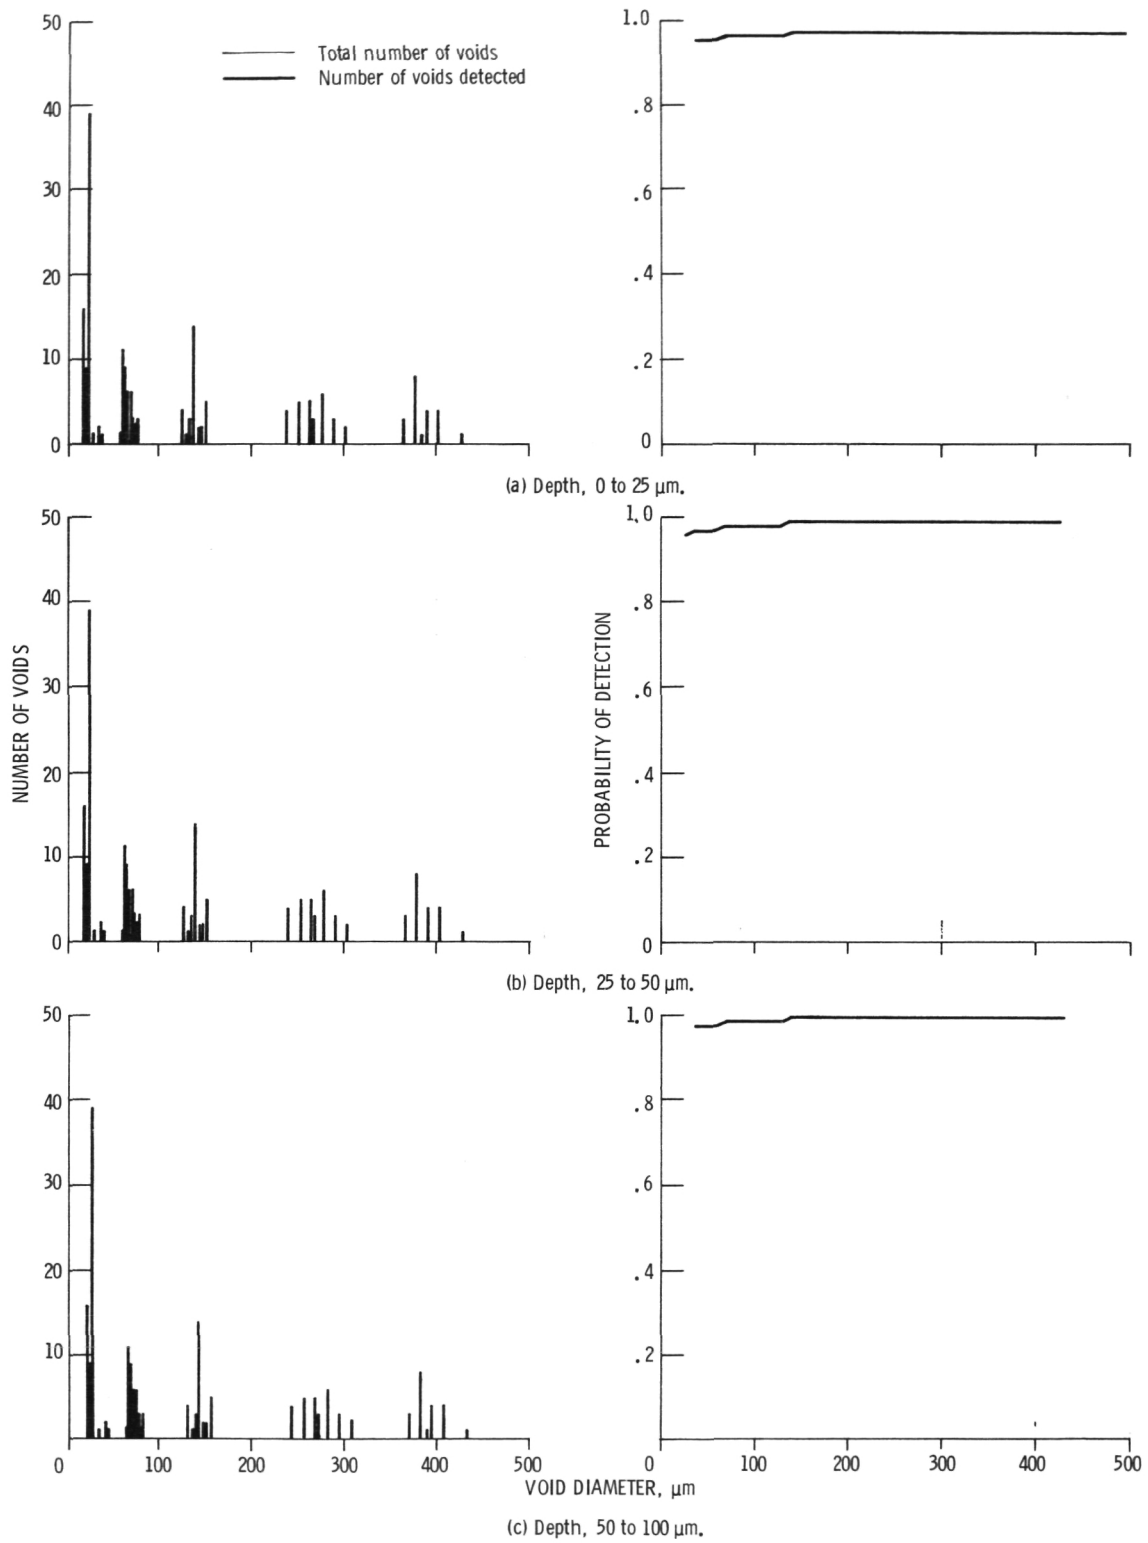
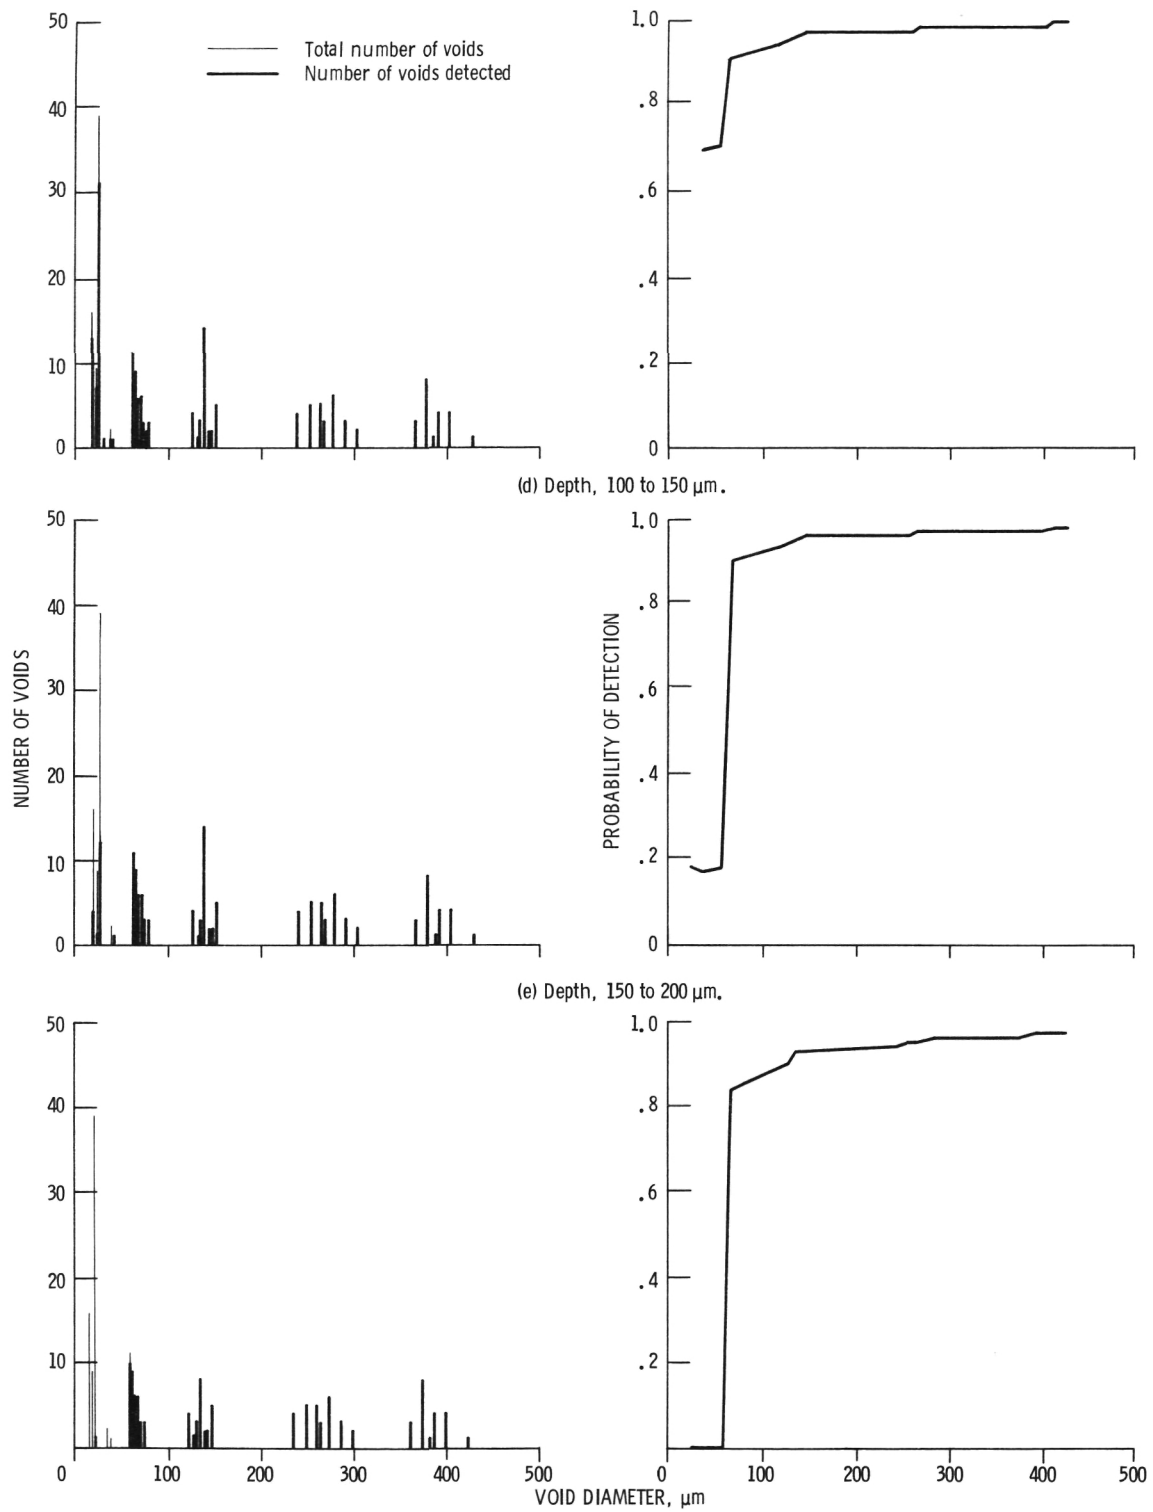
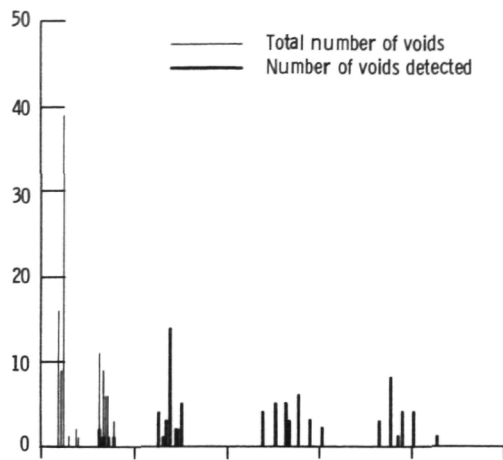
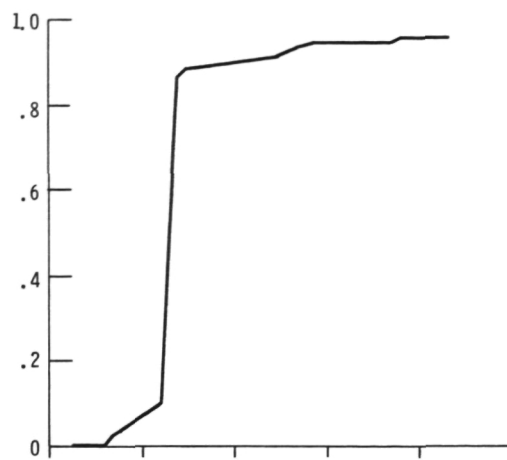
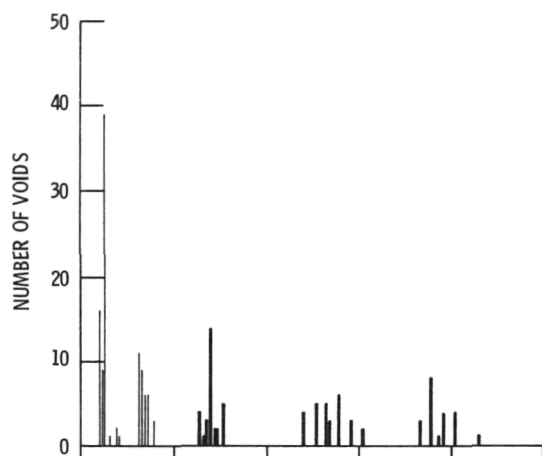
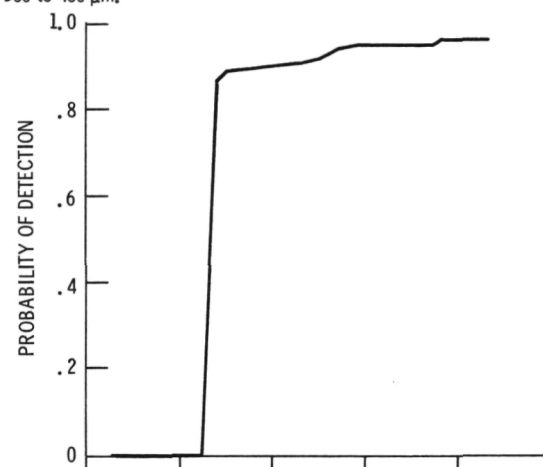
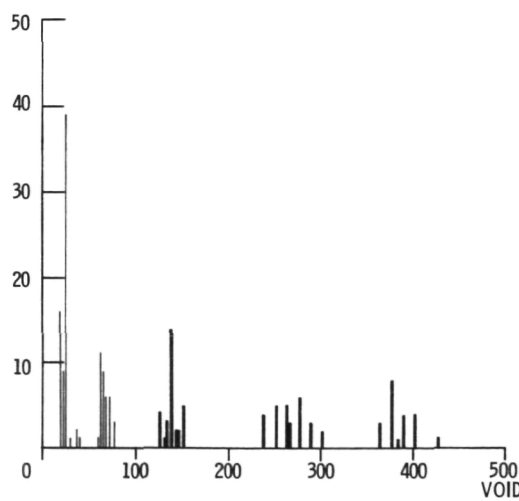
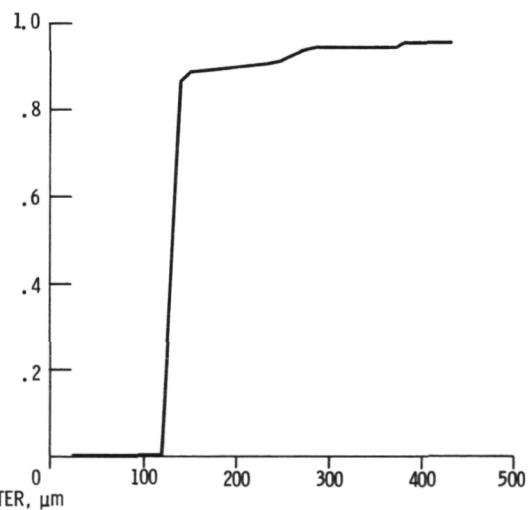
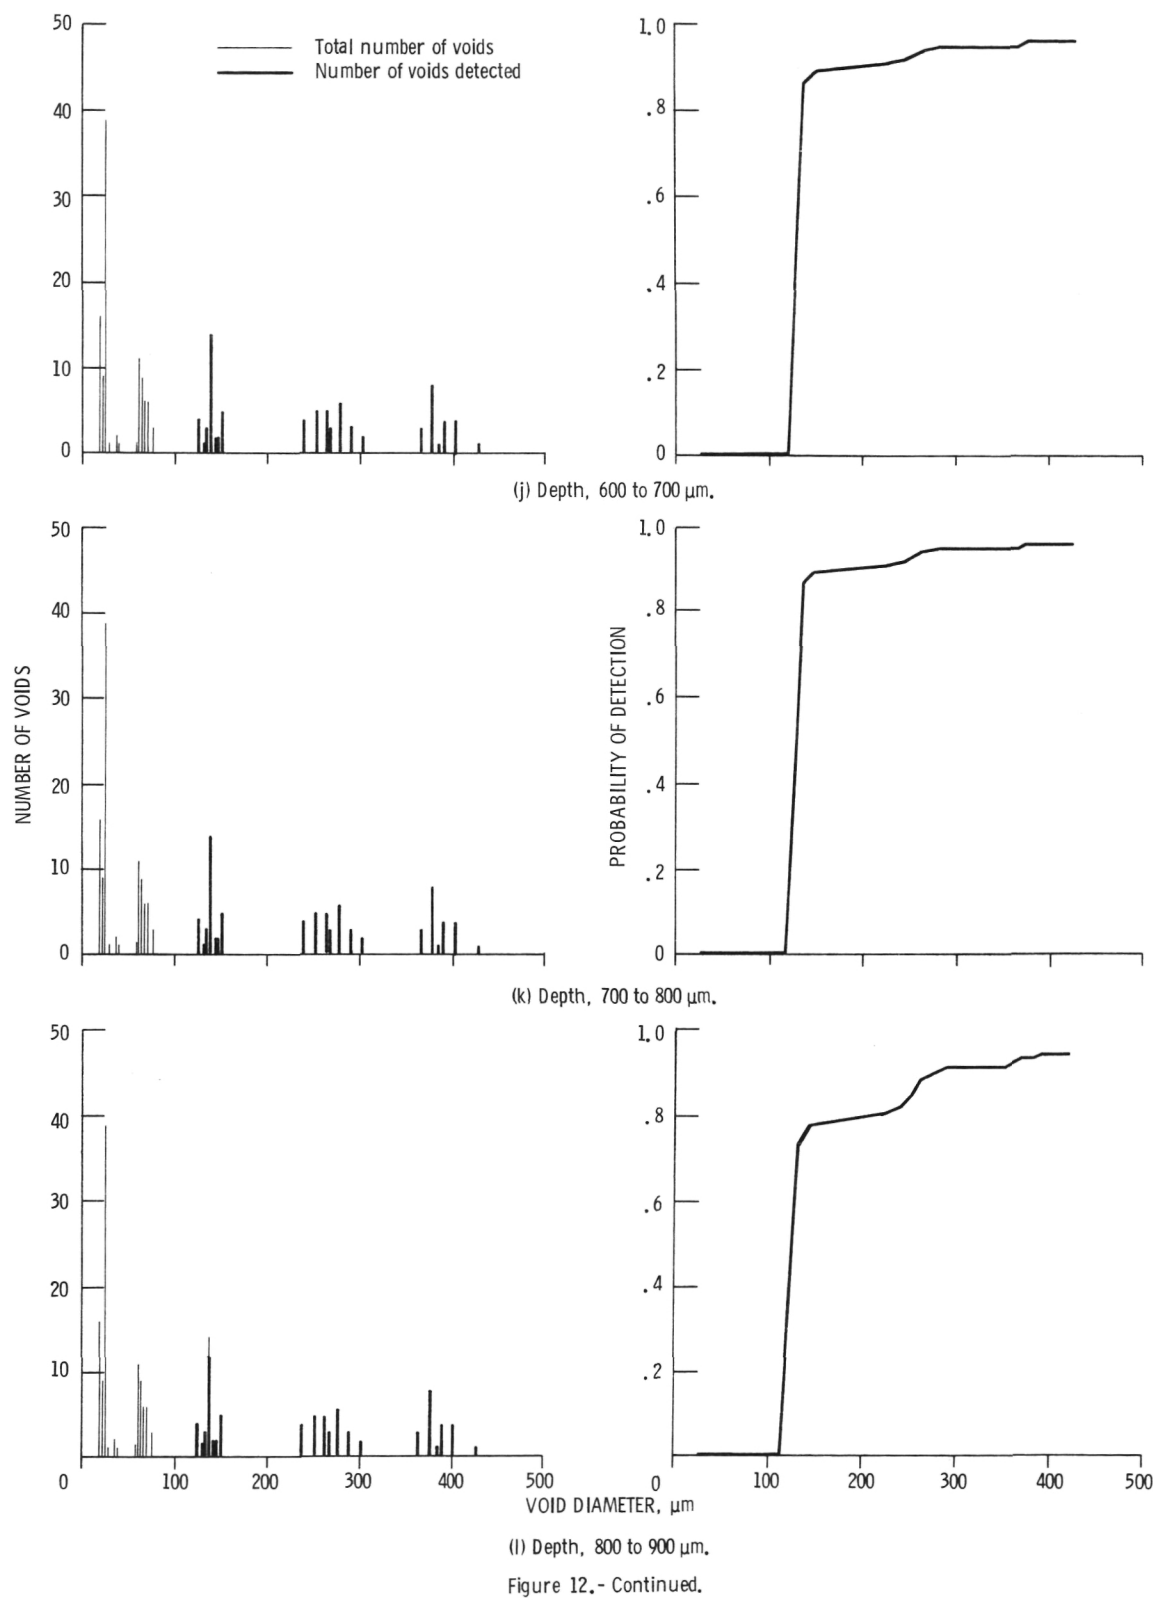
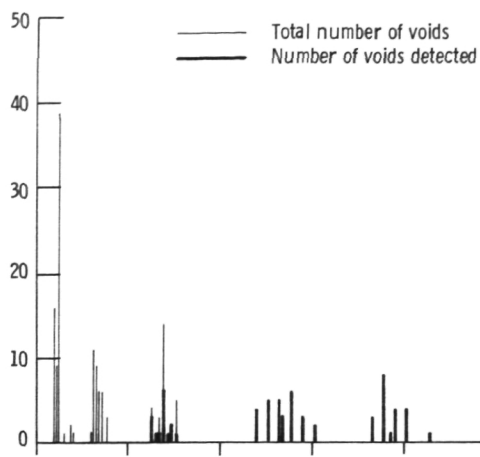
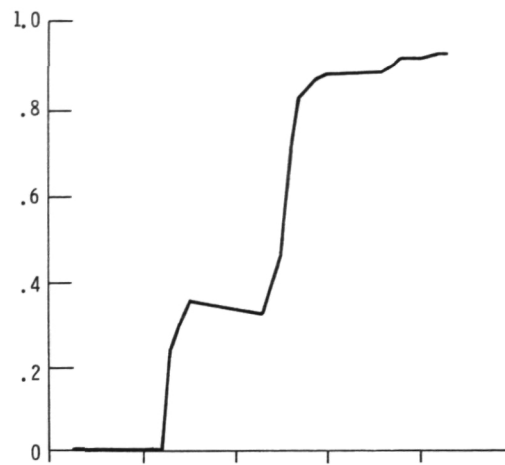
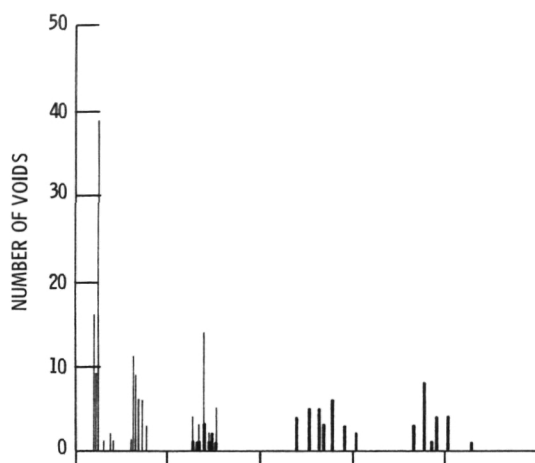
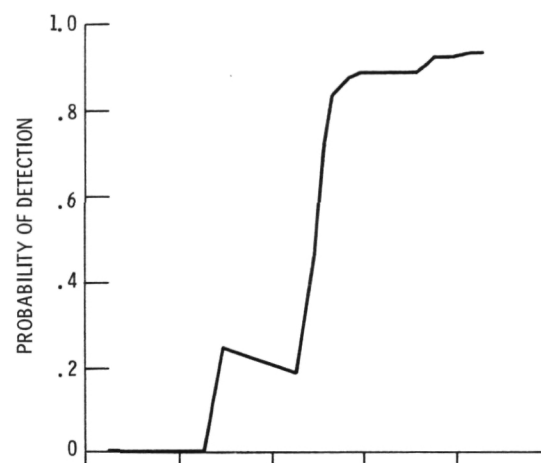
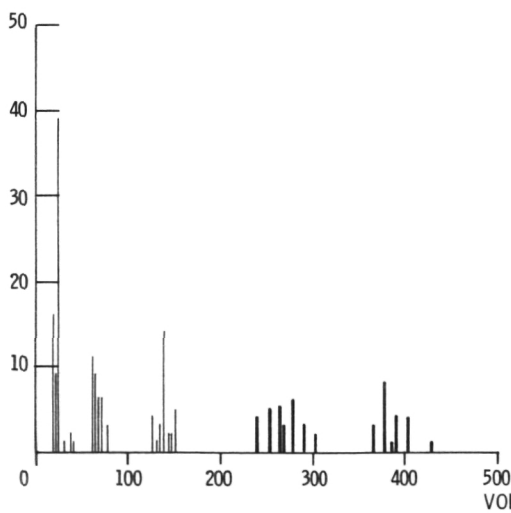
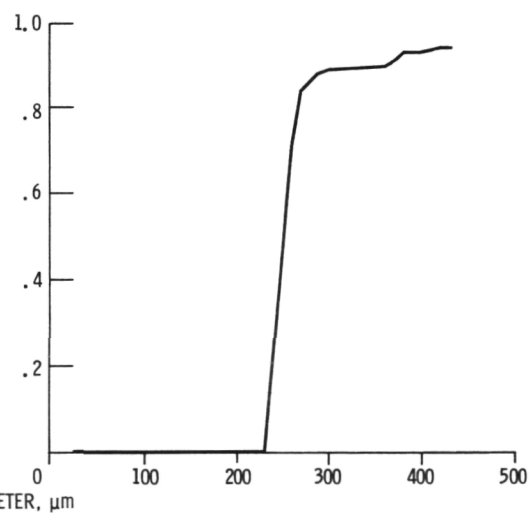
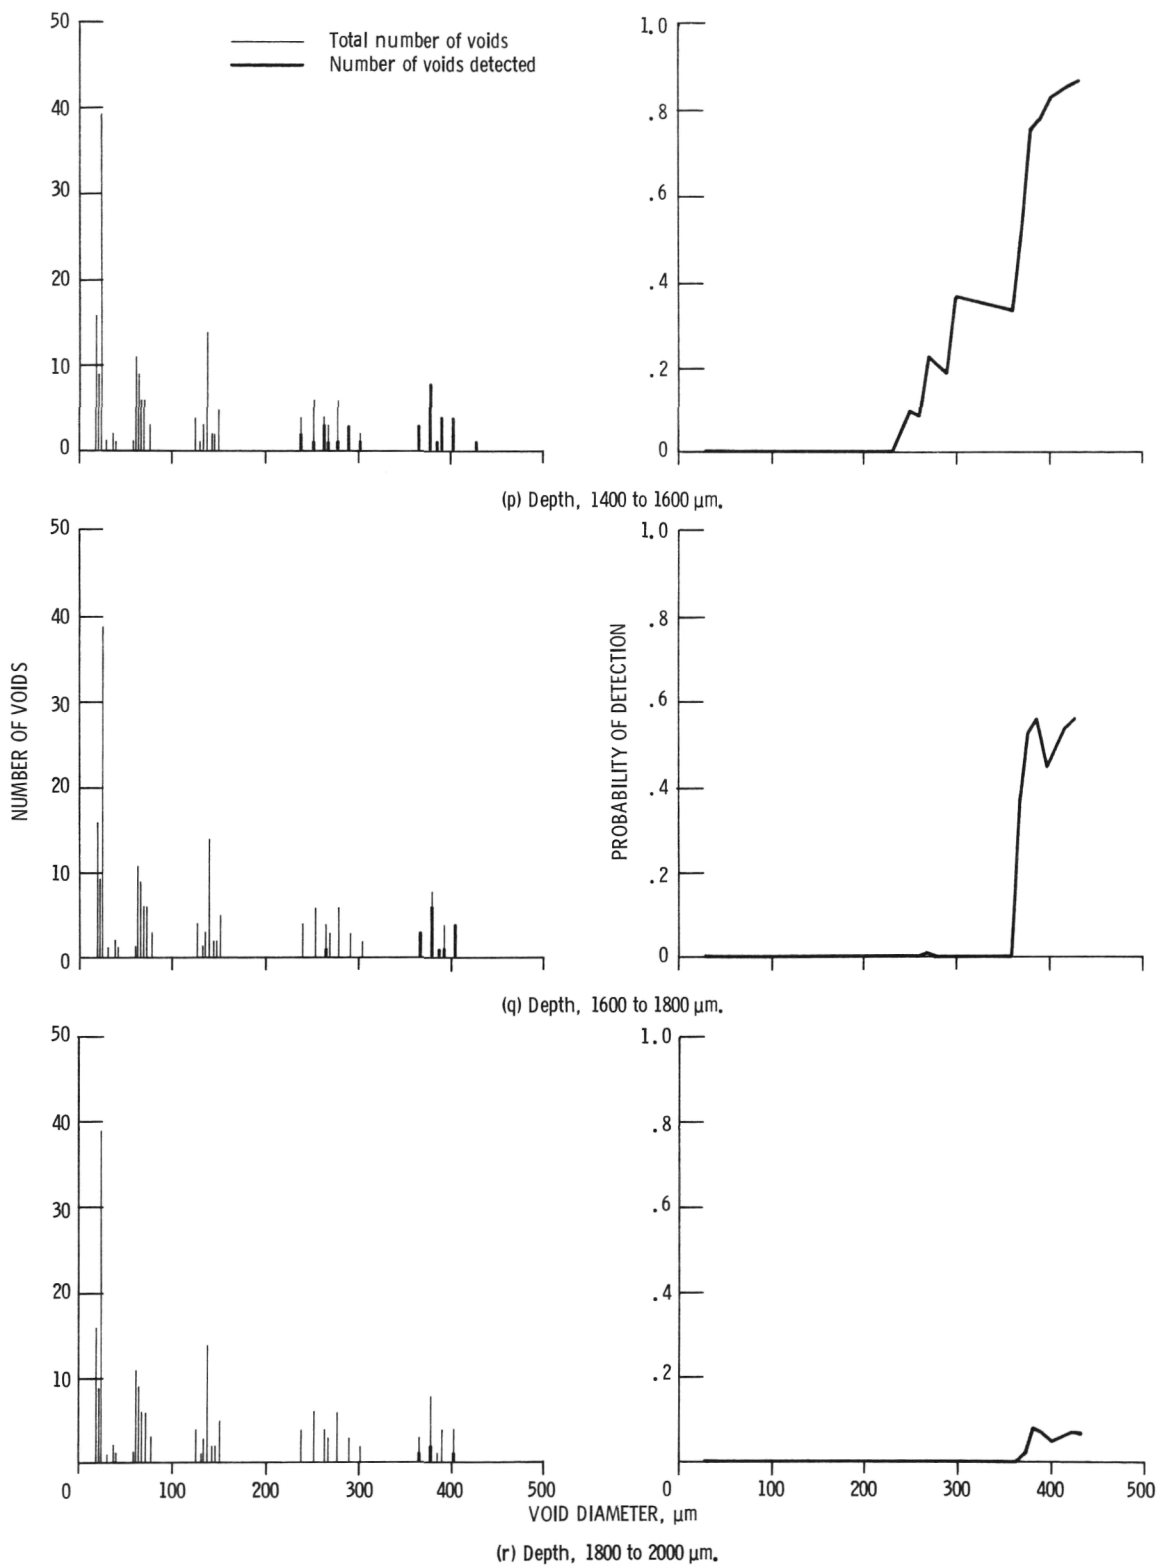
Figure 12. - Detectability data and probability of detection for seeded voids positioned below laser-scanned surface in sintered silicon nitride specimens. Probability calculated at a 0.95 confidence level.

Detectability data and corresponding probability of detection curves at each depth range for the seeded internal voids in sintered silicon nitride appear in figures 12(a) to 12(r).
